NAUTICAL NOTES

NOTE NO 13

Vegetable Oils Outturn

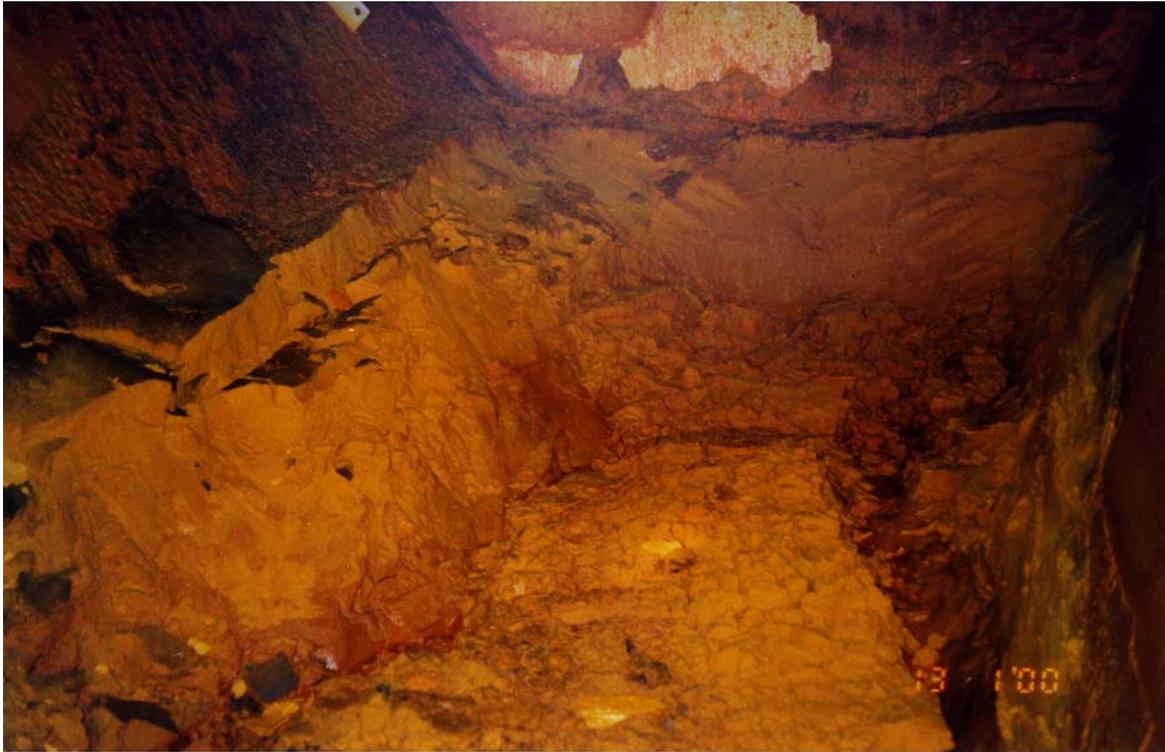
should be pressed up to reach the tank top, in fact this was done in one pair of ballast tanks, probably mistakenly, because one of the cargo tanks above was empty. Needless to say the effect on the cargo tank that was not empty was not noted until much later.

As cargo discharge progressed and we prepared for sweeping operations in the tank in question, nothing untoward was initially noted, pumping was normal, back pressures were normal; but as the cargo got down to a level where we could enter the tank for sweeping it became immediately apparent that something had gone horribly wrong. Hopefully the photograph will give some indication of the disaster.

Yes, the palm oil had gone solid. There was too little oil in the lines to drop back into the tank, there was too little to circulate and the shore had a non-return valve so we could not drop back from the shore tank into the ship. It,

therefore, became a very urgent sweeping job to get out what we could and to live with the rest. The ship eventually had to dig out the remains of the tank and wait for the claims to roll in.

It is incumbent on all involved in these operations to ensure that the rules on discharge are not broken due to a change of staff in the control room (and this ship had a very sophisticated control room) and that everybody not only understands, but believes in and follows those rules.
