Reinstatement of No.1 Buoy – Winter 2011

Replacement of No. 1 Navigation Buoy in the approaches to Burnham on Sea.

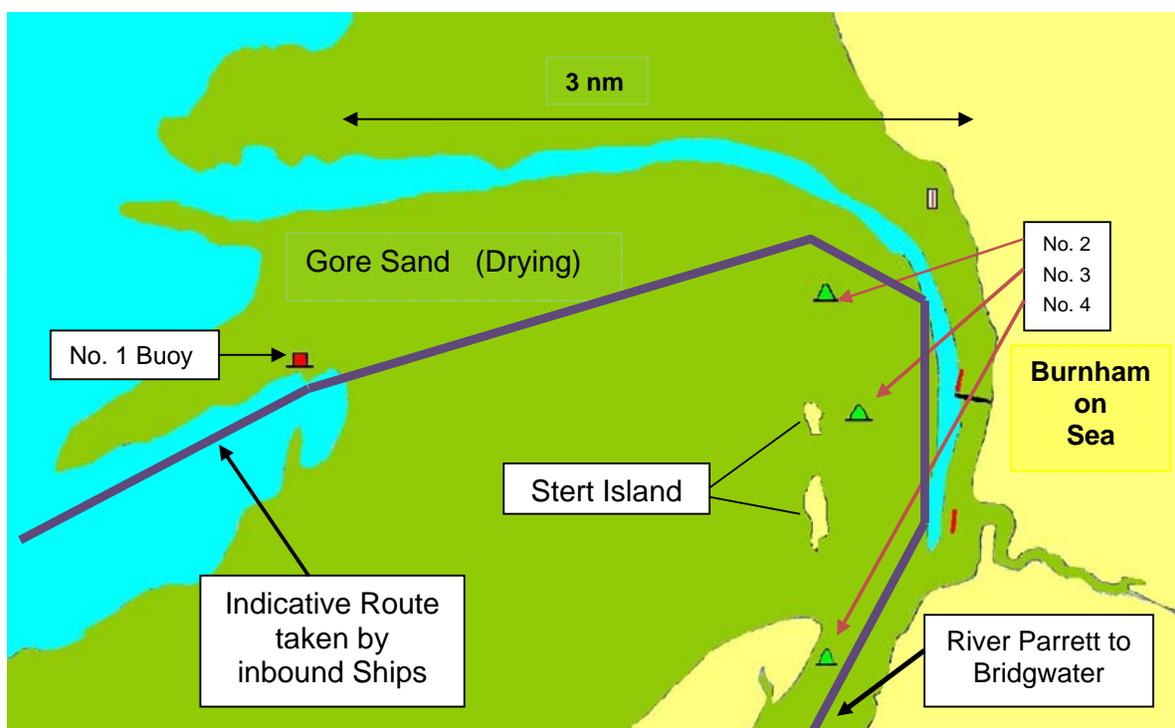
Such was the case in the winter of 2010 / 2011 when it was discovered that No 1 Buoy normally in position on the drying sandbar some 3 miles off the seafront at Burnham on Sea had beached on Stert Island, half a mile from the seafront. The local RNLi seeing an opportunity for a different form of exercise, “rescued” the buoy and brought it safely to shore. With the buoy ashore it was evident that the cause of its wandering was a failed swivel.

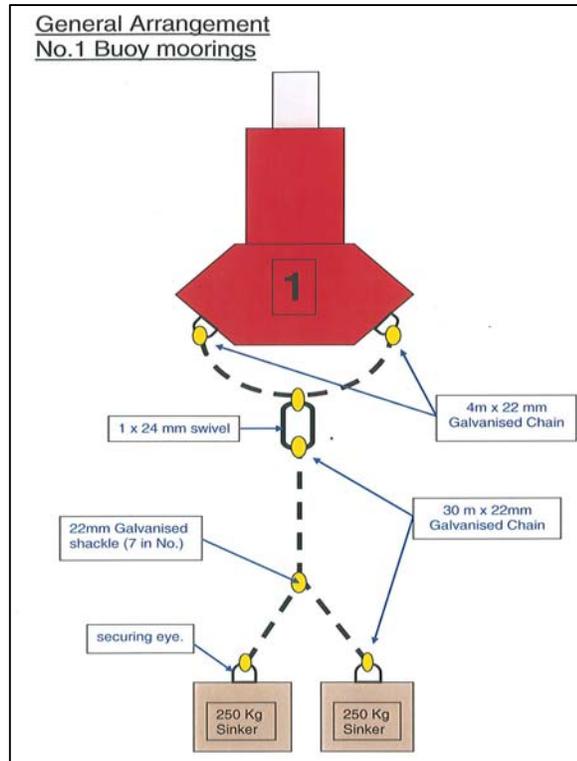
The general arrangement plan shown was included within the specification to indicate the requirements showing lengths and specification for chain, shackles and swivel.

1 x sinker at minimum 500kg (or 2 x 250kg) with securing eye(s).

Note:- Arrangement last used comprised 2 x 250kg concrete sinkers fitted with 24 mm rebar as securing eyes.

22mm Galvanised shackles.

24 mm swivel to fit between chain and the buoy

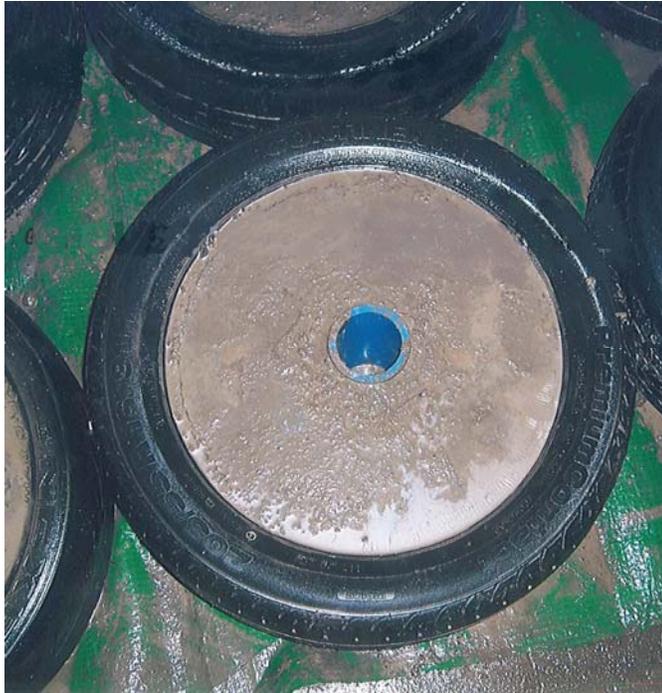
Works commenced. The method involved pre casting a number of concrete sinkers using old tyres as formers, which allowed the sinker segments to be more easily manhandled when assembling the final composite sinker arrangement.

Each cast segment weighed approximately 112 kgs and the contractor intended to use a total of 6.

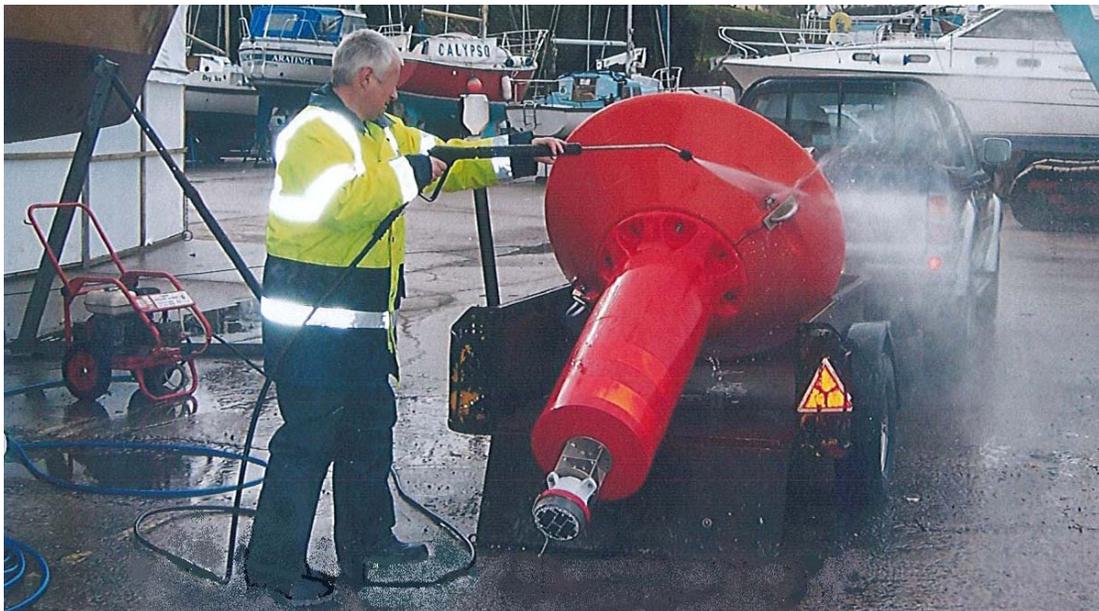
The buoy was pressure washed and all exposed metal work was painted before being reinstated in its original position on Gore Sands off Burnham on Sea.

With the buoy gleaming, exposed metal painted and all the sinker segments, chain, shackles and other fittings ready the workboat departs port with the buoy on tow.

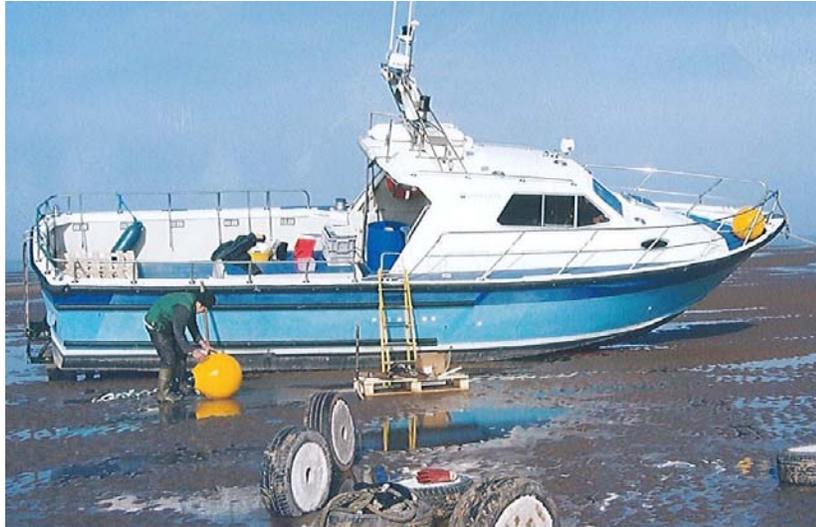
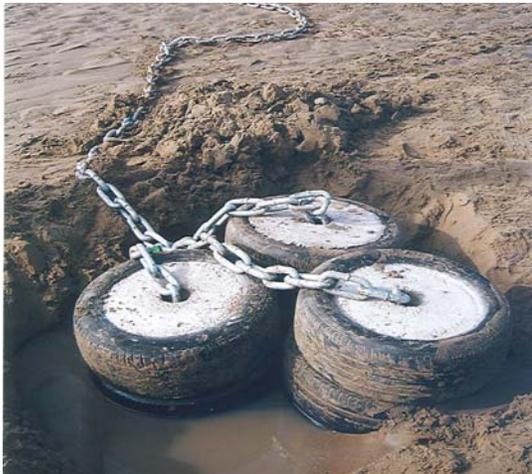
The workboat took the ground in the position detailed for the sinker and offloaded the components ready for assembly.

This is where the sinker design comes into its own as the segments can be rolled into the desired position.

It was then simply a case of creating a sinker mass in excess of 500 kg by forming the sinkers into three towers of two and linking them with chain.

For added security the sinkers were partly buried in the sand.

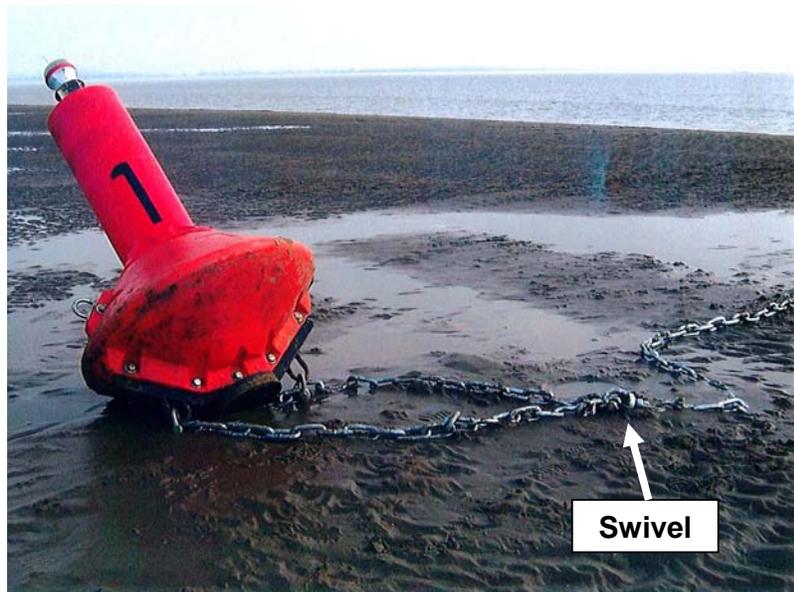
With the bridle and swivel attached the job is complete. All that remains now is for the flood tide to lift both the buoy and workboat.
